DEPARTMENT OF TRANSPORTATION

Contract #: 04-0120F4Cty: SF/ALA Rte: 80 PM: 13.2/13.9File #: 99.28**WELDING INSPECTION REPORT****Resident Engineer:**Siegenthaler, Peter**Address:** 333 Burma Road**City:** Oakland, CA 94607**Report No:** WIR-019005**Date Inspected:** 03-Jan-2011**Project Name:** SAS Superstructure**OSM Arrival Time:** 700**Prime Contractor:** American Bridge/Fluor Enterprises, a JV**OSM Departure Time:** 1900**Contractor:** Zhenhua Port Machinery Company, Ltd (ZPMC)**Location:** Shanghai, China**CWI Name:** Li Yang and Zhu Zhong Hai**CWI Present:** Yes No**Inspected CWI report:** Yes No N/A**Rod Oven in Use:** Yes No N/A**Electrode to specification:** Yes No N/A**Weld Procedures Followed:** Yes No N/A**Qualified Welders:** Yes No N/A**Verified Joint Fit-up:** Yes No N/A**Approved Drawings:** Yes No N/A**Approved WPS:** Yes No N/A**Delayed / Cancelled:** Yes No N/A**Bridge No:** 34-0006**Component:** OBG Trial Assembly**Summary of Items Observed:**

Orthotropic Box Girder (OBG) at Trial Assembly Areas

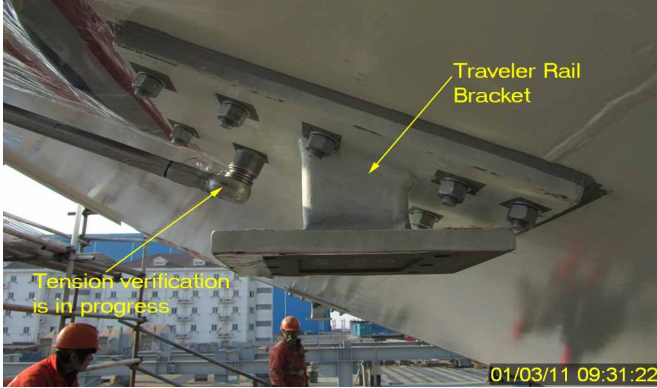
This QA Inspector witnessed the final bolt tension verification on bolts connecting the Traveler Rail Bracket to the Side Panel, Bike Path side at Panel Points (PP) 95, PP 96 and PP 97 for Segment 11AE. The QA Inspector verified the bolt tension on a random basis and the results appeared to be in general compliance. The Inspection was performed against Notification No. 00594 dated January 03, 2010.

Segment 11AE. Traveler Rail Brackets installed at Side Panel Bike Path side bolts tension verification is in progress at PP 96.

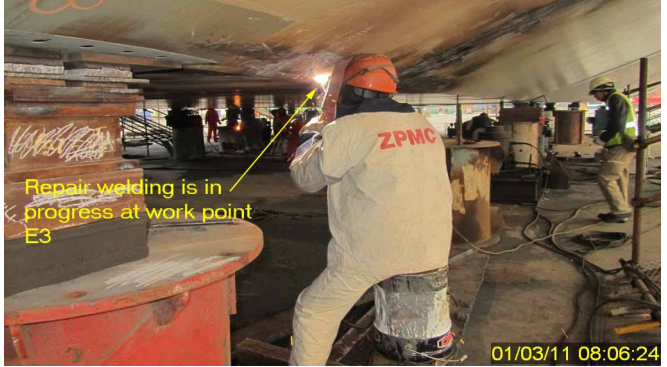
This QA Inspector observed the repair welding by Shielded Metal Arc Welding (SMAW) process on a Complete Joint Penetration (CJP) groove weld. The Weld joint was designated as Seg3001A-004. The welder identification was 044515 and was observed welding in the 4G (Overhead) position using approved Welding Procedure Specification WPS-345-SMAW-4G(4F)-FCM-Repair-1. The piece mark was identified as weld connecting Bottom Panel to Side Panel hold back weld at work point E3. ZPMC performed repair welding in accordance with Welding Repair Report B-WR19749 dated Jan 01, 2011.

Segment 12AE. Bottom Panel to Side Panel connecting hold back weld repair welding is in progress at work point E3, in OBG Trial Assembly area.
